PRELIMINARY INSPECTION RESULTS

Jason Sobczynski
Next Generation Rail Services

Zach Hall
Steamman Rail Services

READING 2100 PRELIMINARY INSPECTION RESULTS

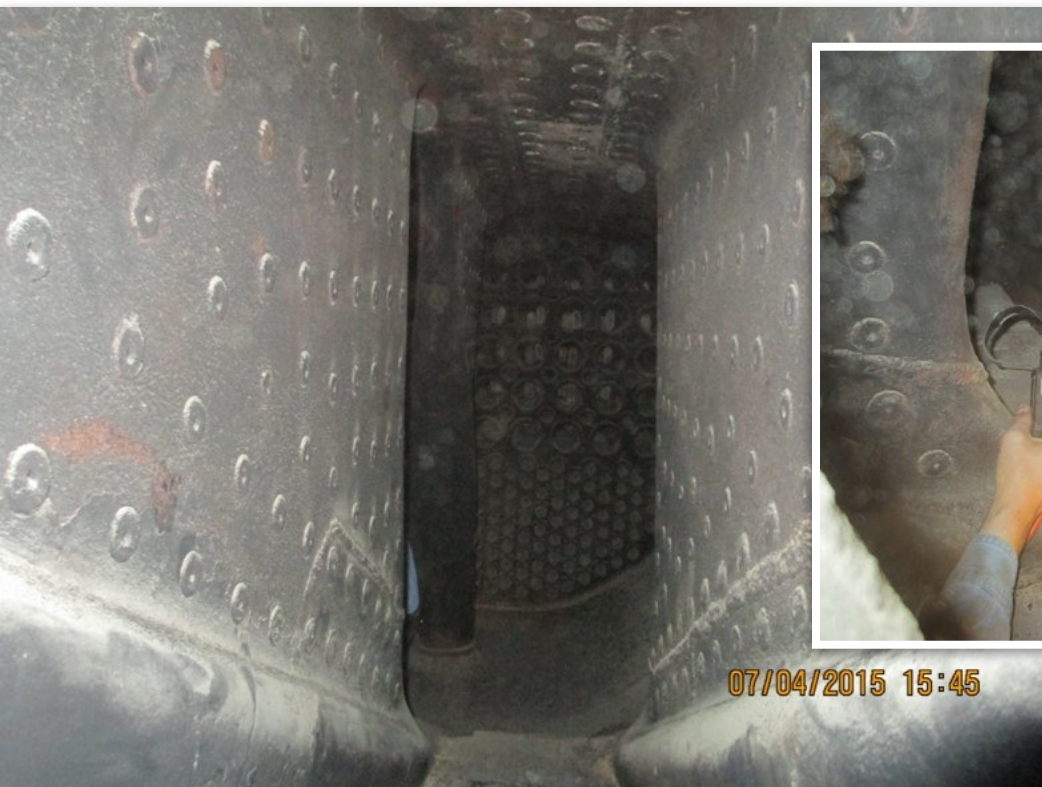
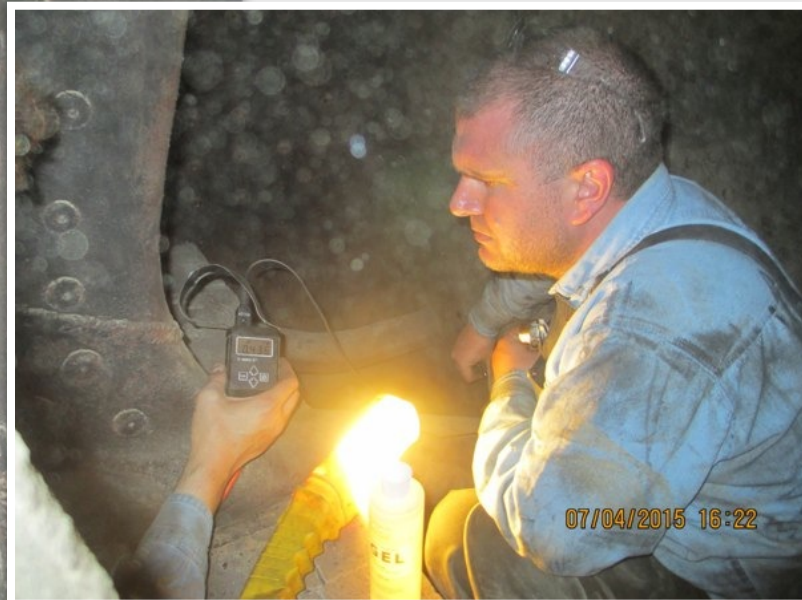
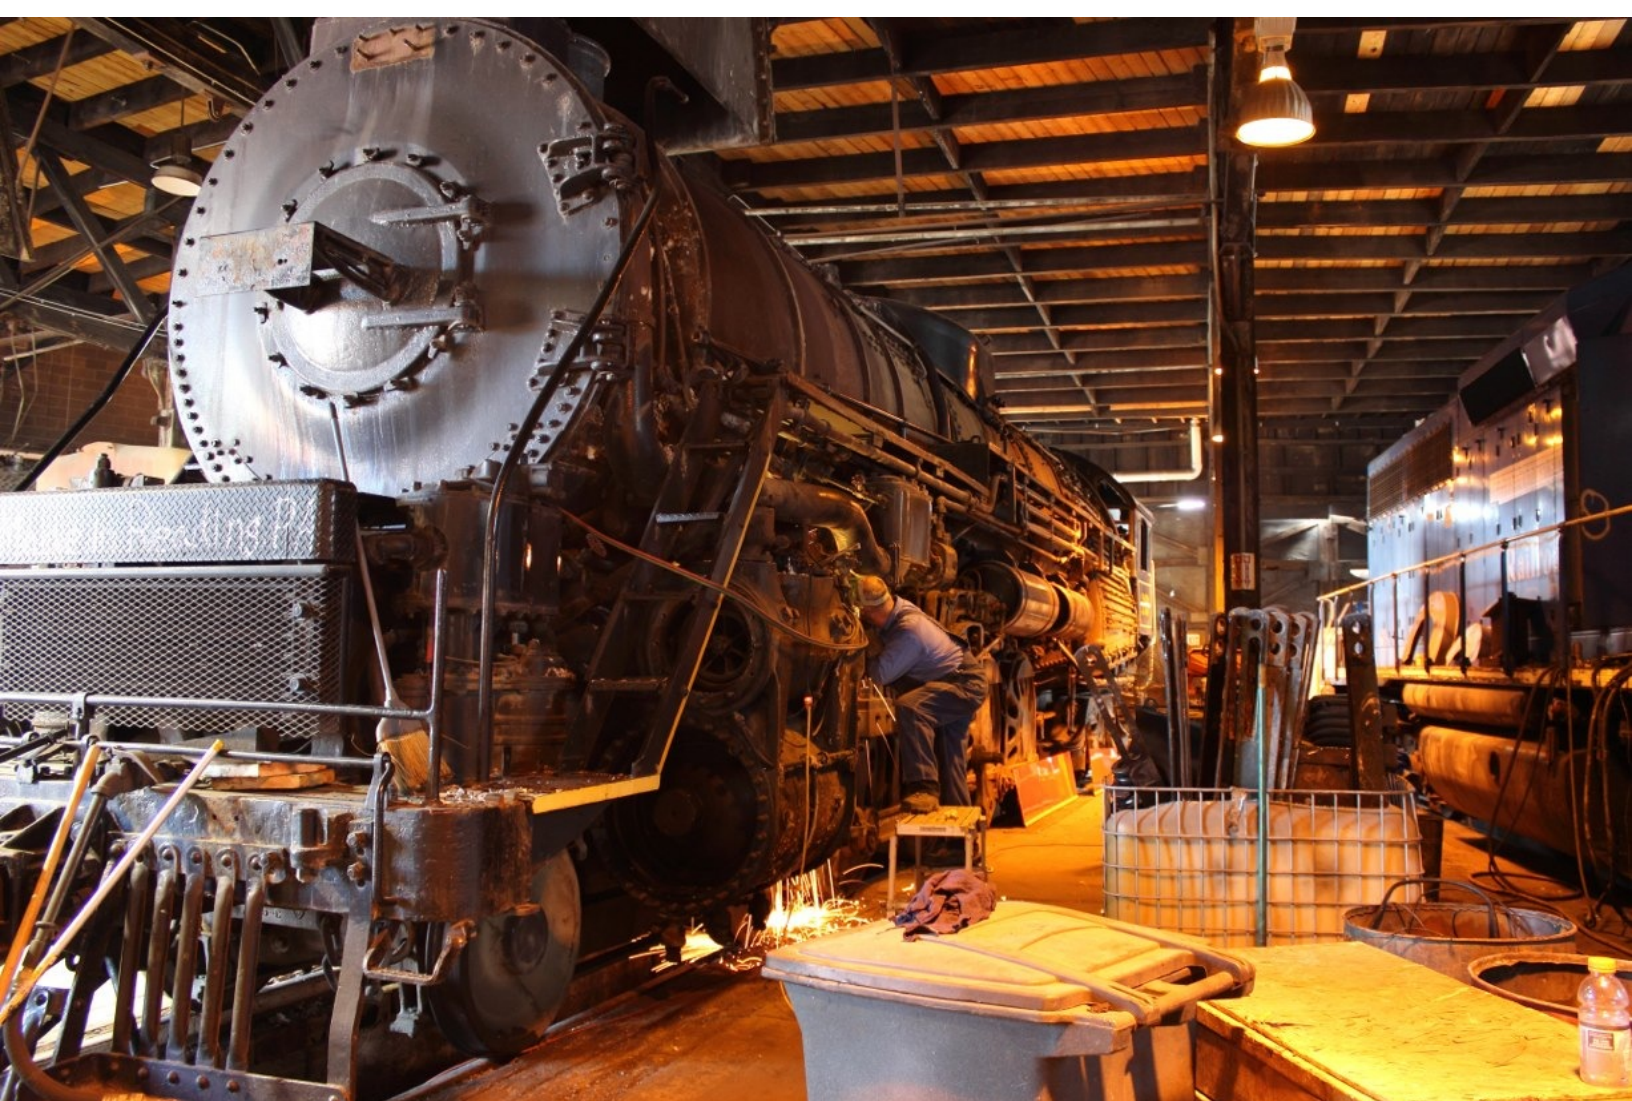
Upon engaging into the preliminary inspection our first objective was to determine what, if any, damage had been done to the interior firebox of the locomotive as a result of the conversion to oil. The actual condition of the firebox is very good. Despite our best efforts we were unable to locate waffled, bagged, or burned sheets in either the firebox itself or the thermic syphons and only minor leaks were noted around a few bolts. The only notable repairs required within the firebox pertain to the syphon “diaphragms” and the replacement of about 60 crown bolts which no longer have a “head” protruding above the sheet. Many locomotives currently in service would be lucky to have a firebox in this good of condition.

Following the empirical observation of the sheets’ condition, we engaged in determining the condition of the sheets for the purpose of refreshing the locomotive’s Form 4. It was discovered that the average sheet thickness of the crown sheet, doorsheet, sidesheets and syphons is around .430, which is almost 1/8” above the minimum thickness. It is unknown why the Reading chose to utilize such a very thick material (original thickness was likely 15/32”) as all of the blueprints call for the application of 3/8” plate.
